# **Shuttle Liquid Hydrogen (LH2) Engine Cut-Off (ECO) System Anomaly**

**Michael D Stirling**

**NASA Electrical Systems**

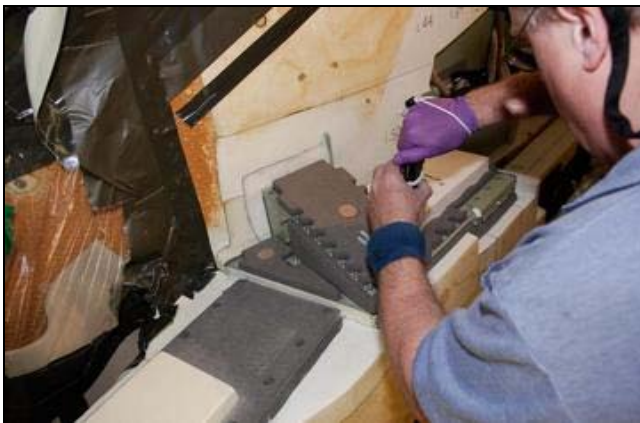
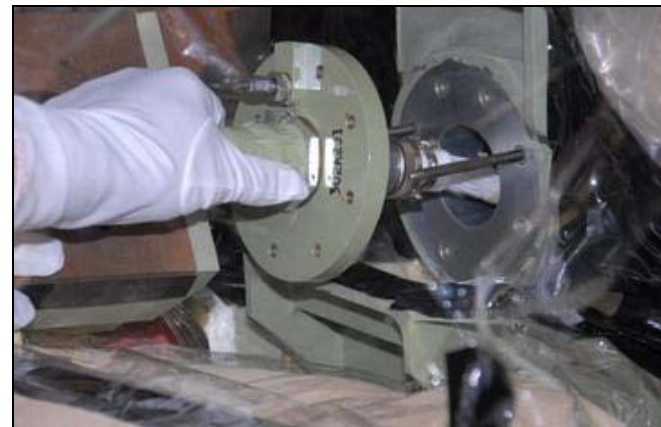
- All circuit anomalies experienced during testing were able to be repeated as seen during the two launch attempts and tanking test.
- Open circuits in the part that connects wires from the interior to the exterior of the liquid hydrogen tank, commonly known as the feed through plate, were identified as the culprit that caused false readings during two launch attempts and a tanking test in December 2007.
- The external plug and feed through connector were removed from the tank and shipped to Marshall Space Flight Center in Alabama to determine whether the failure could be recreated in a test facility using focused and limited nondestructive and destructive physical tests. The tests were configured to replicate tank chill down temperatures, loading pressures and environmental conditions during the two launch attempts.

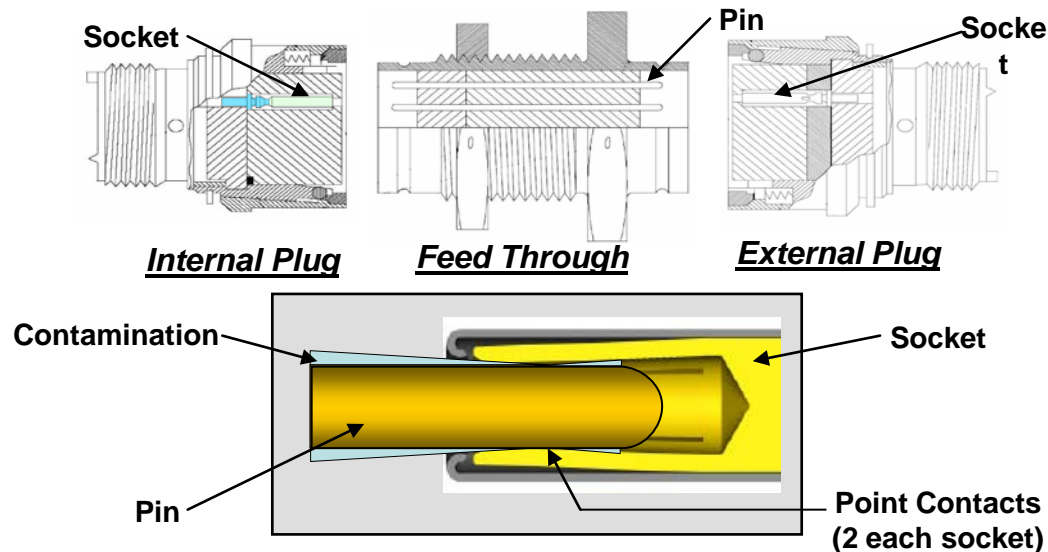
- Additional testing at KSC Cryo Lab determined Liquid air / moisture combined with Krytox® and/or silicon oil residue can create a layer of frost under cryogenic conditions allowing for intermittent open circuits to form as subtle movements (thermal contractions) of the External Tanks external feed thru connector.
- Minute amounts of Krytox® and silicon were found on the external connector.
- The external connector is exposed to air and humidity while the internal connector is enclosed in the Helium purged LH2 tank.

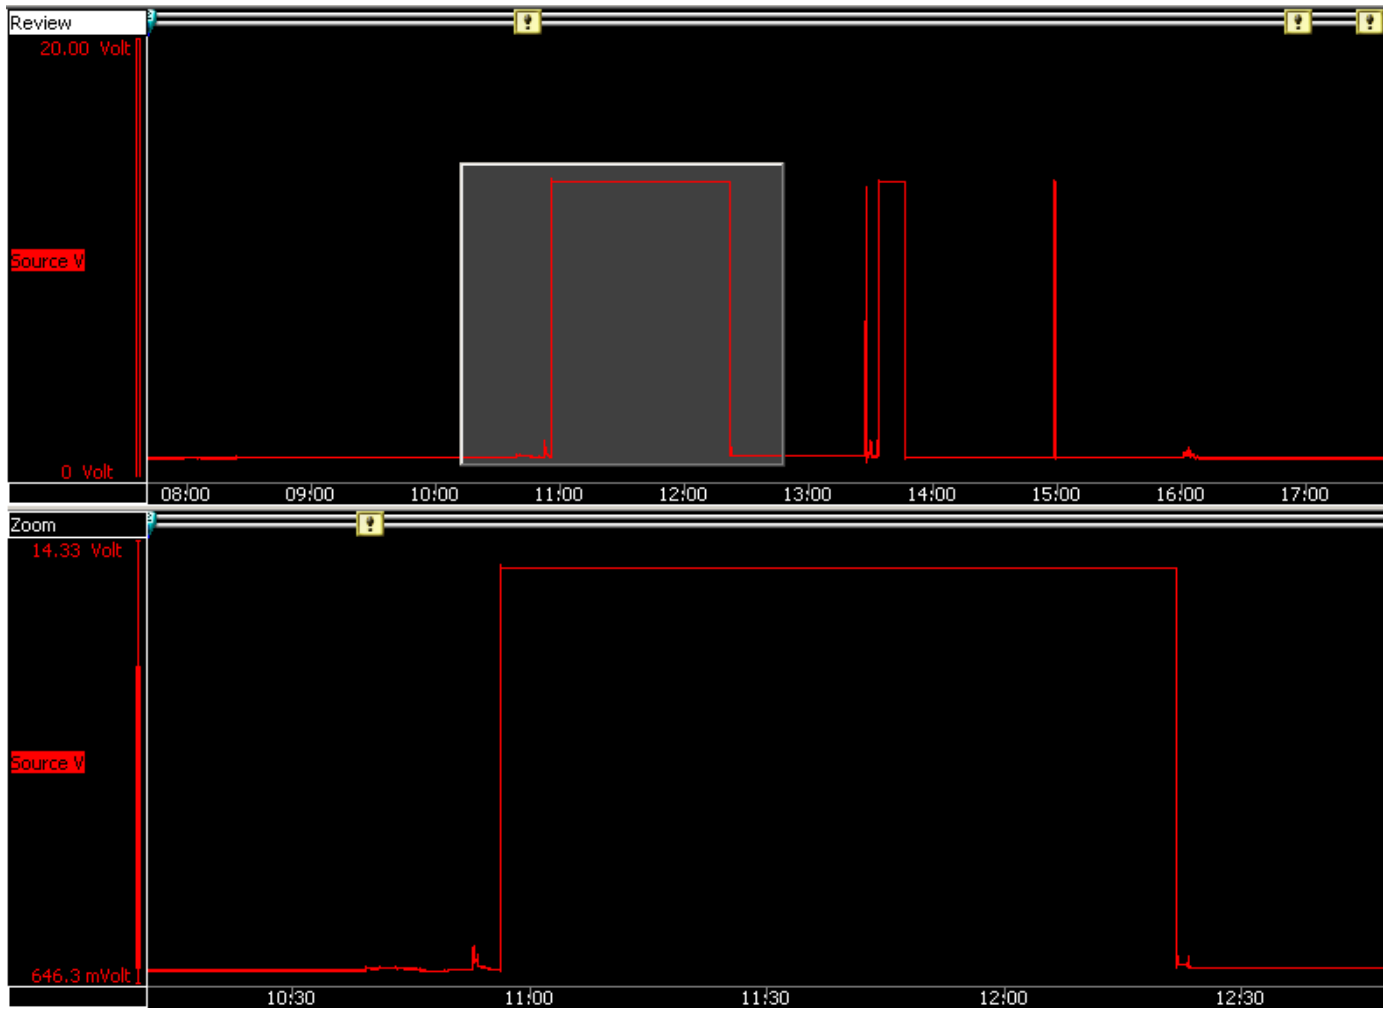
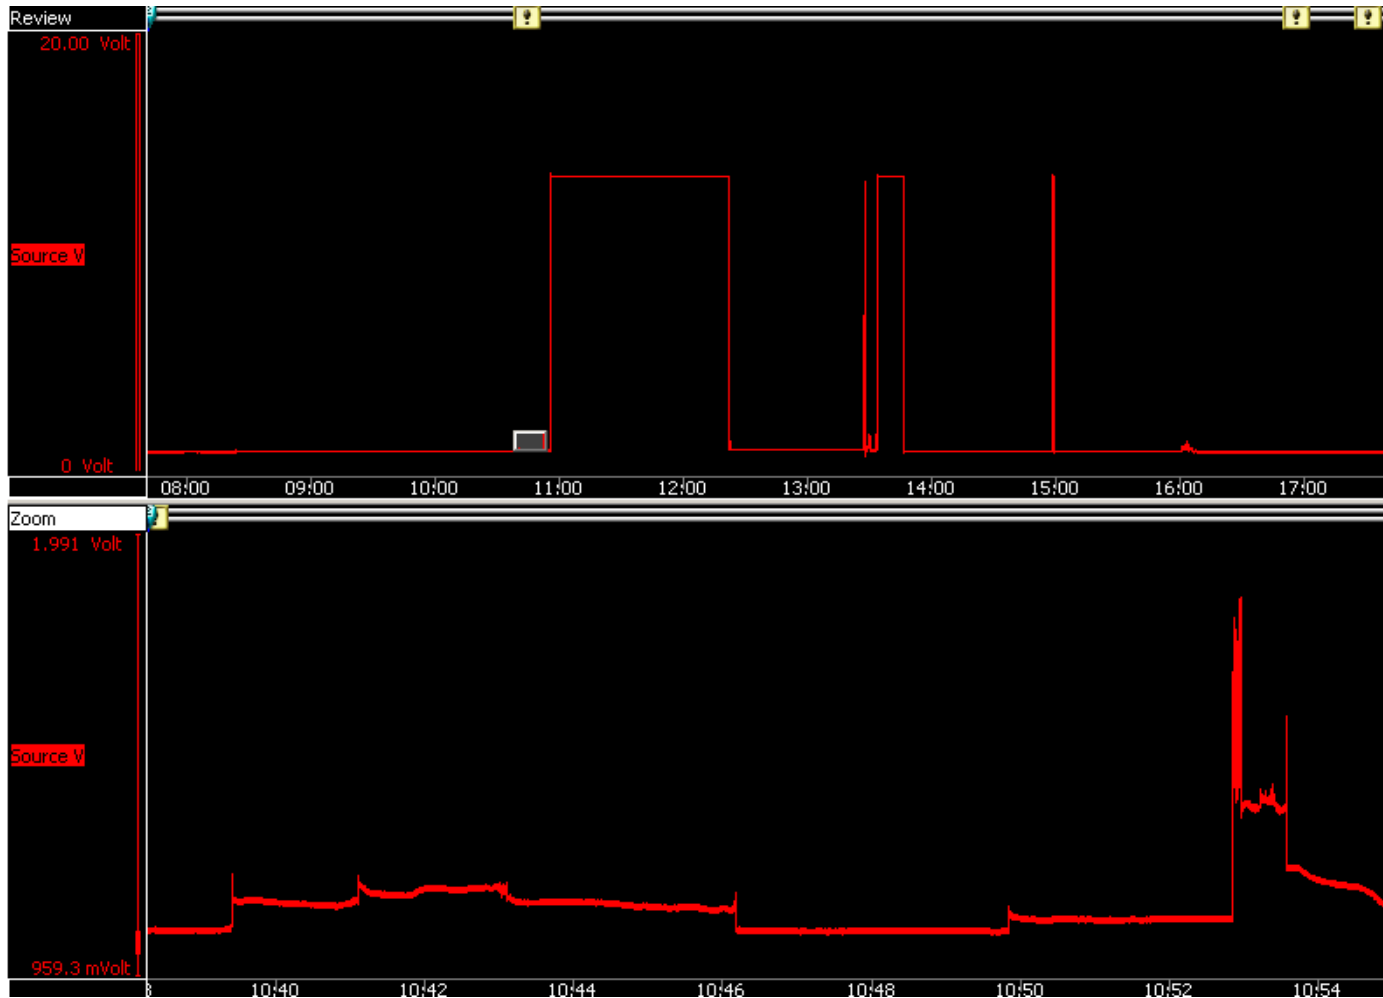
## Krytox® 240 AC + moisture

Krytox® / Water (2)\*

Noise precursor, mostly open (required about 1  
3 mils to initiate open)

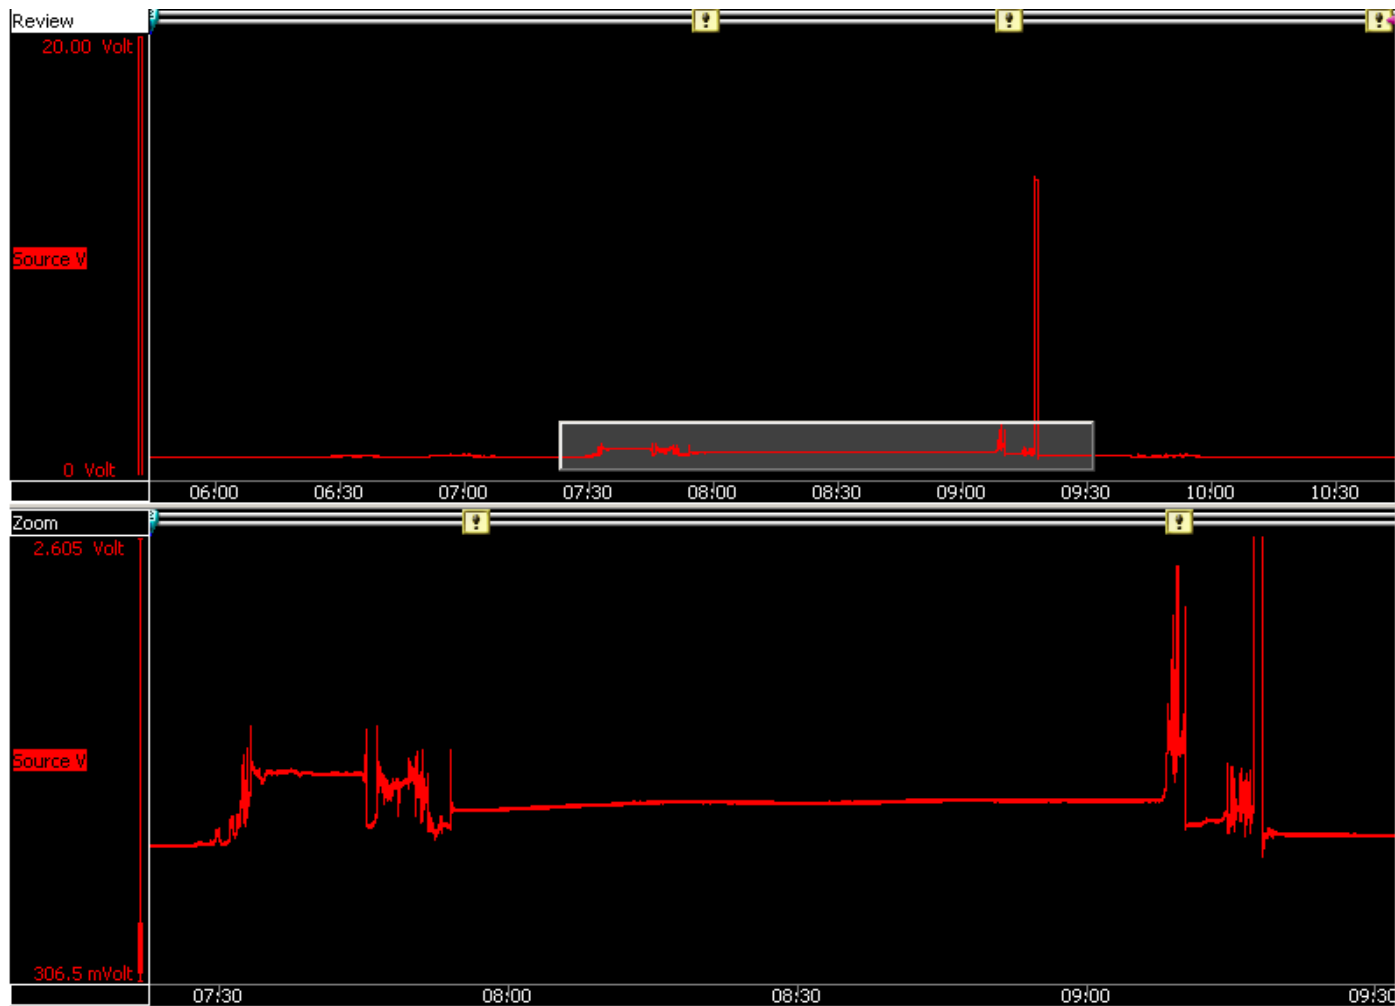
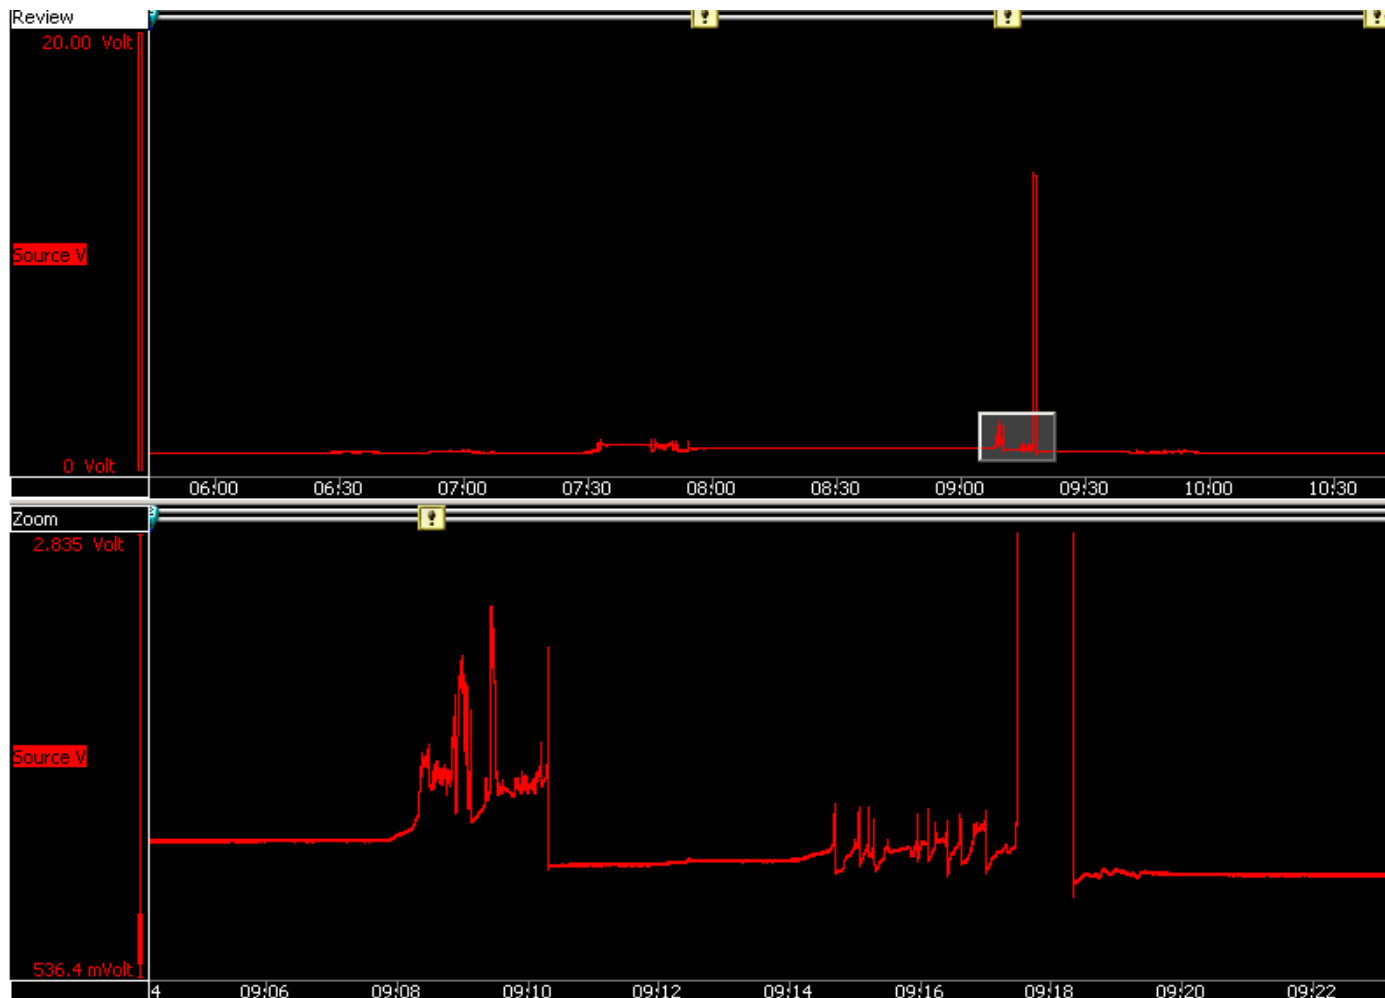
## Moisture/water ONLY

Frost / Condensate (4)\*

Some noise, one short transient open

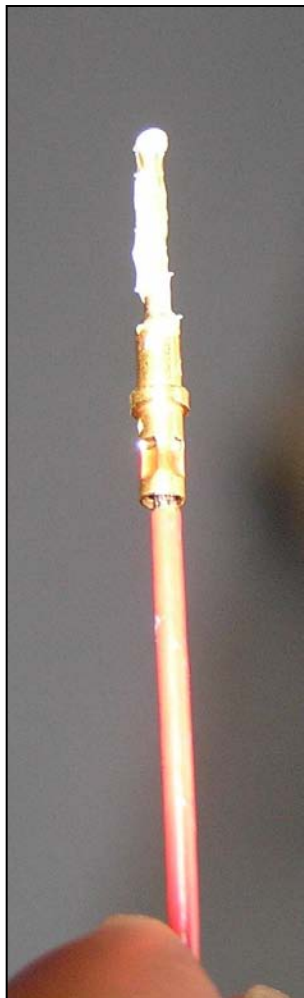
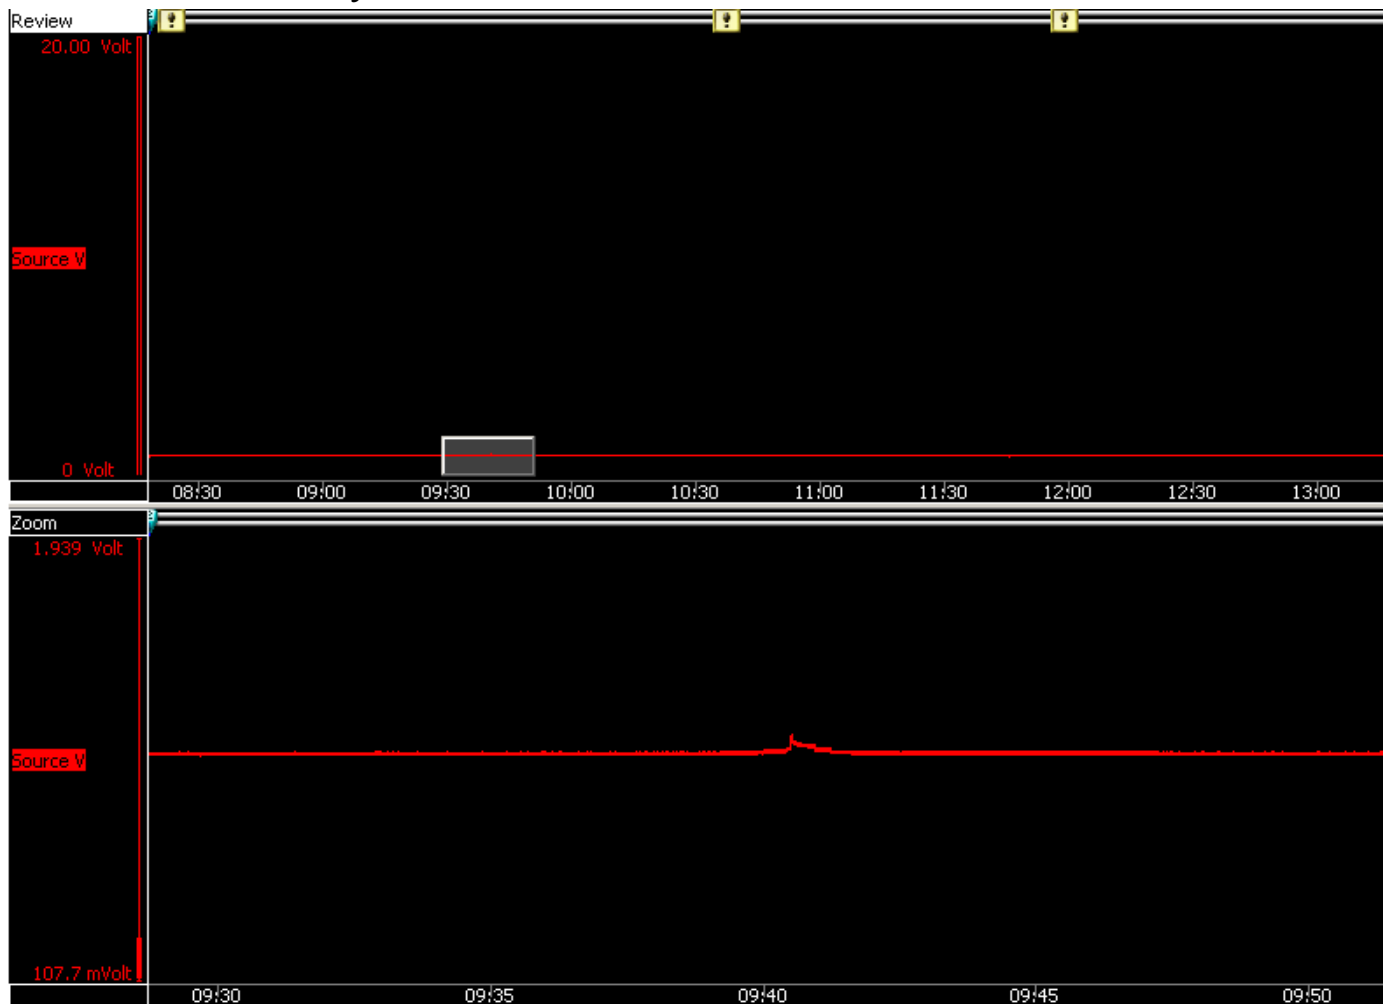
## Krytox® 240 AC ONLY

Krytox® 240 AC Grease and Krytox® 143 AC (>6)\*

No noise (1 instance of min noise), no opens

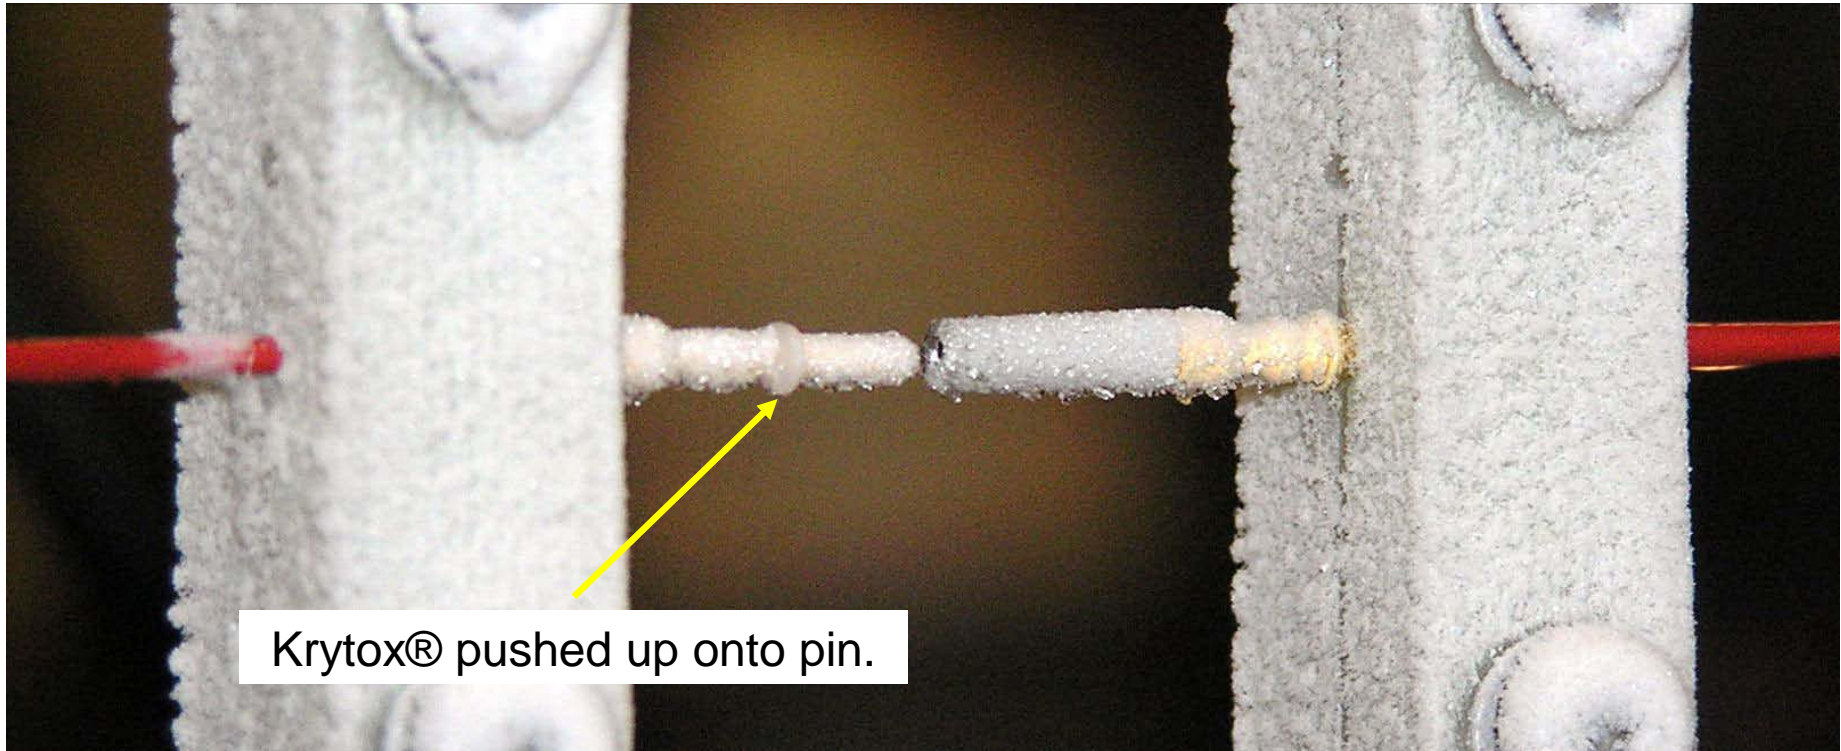
Frost formation on Krytox® 240 AC coated pin/socket after immersion in LN2 for at least 3 minutes beginning to melt.
